Green SRF Wastewater Project ~ Phase 3
Left Fork Watershed of the Mud River

Lincoln County Commission ~ WV DEP ~ WV DHHR
Cooperative Project

FINAL REPORT PHASE 3

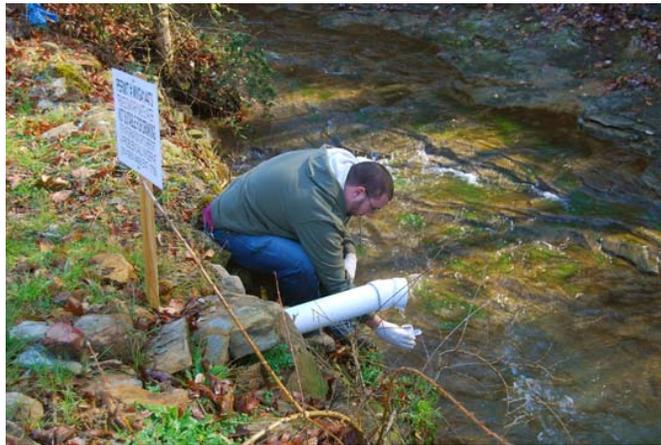
Direct discharge sampling

Direct Discharge Sampling. All of the systems installed in Phase 3 are direct discharge systems (the final treated effluent discharges into the creek). Since the beginning, the Project has periodically sampled the final discharge from direct discharge systems where they empty into the Left Fork's tributaries. During Phase 3, from August 2011 through March 2012, 72 direct discharge samples were taken. Only 4 were over the acceptable limit of 200 E. coli colonies. Of these, 2 samples were taken where problems were discovered in the UV light preventing adequate final decontamination. The other 2 were taken at a home where a child was using strong antibiotics that often kill the good bacteria needed in the septic tank. Of the 68 samples under 200 colonies, 58 or 85% had <10 colonies per 100 mL. All of the homes in Phase 3 had failing septic systems prior to new installations. *Because all of these new systems are direct discharge they immediately have had positive impact on human and ecological health.*

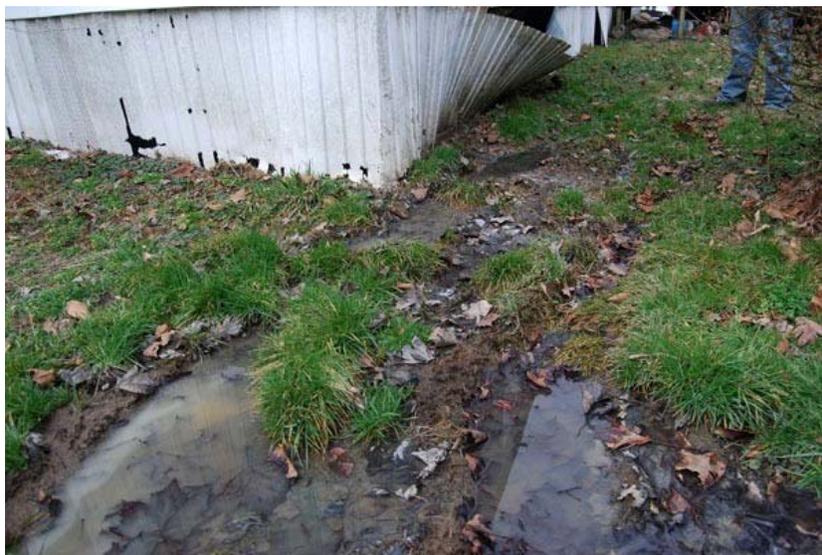
One of the more extreme situations showing raw sewage flowing from under a mobile home. This family received a new system under Phase 3.

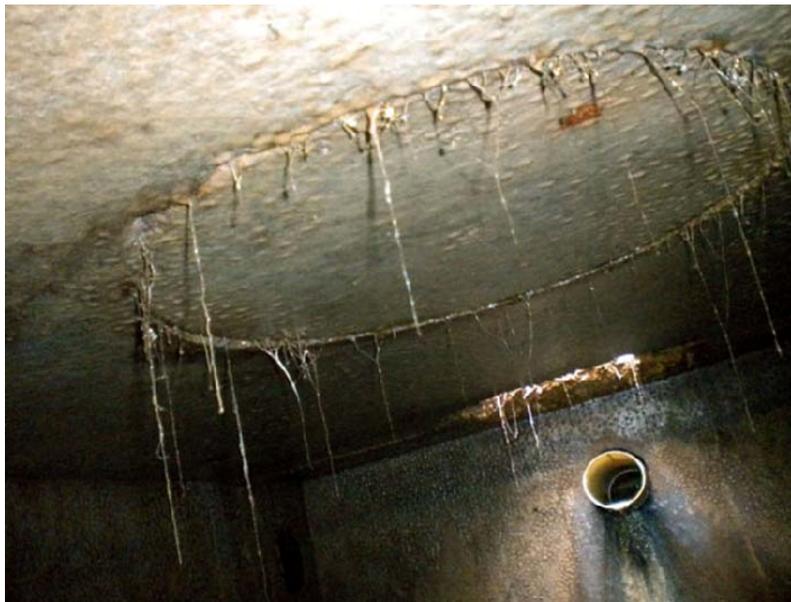
Interior of concrete pump tank showing infiltration of roots and ground water

Leaking Concrete Tanks. When Phase 1 began in 2005, concrete septic and pump tanks were used. By the end of 2009, the Commission had decided to stop using concrete tanks. Too many of them leaked, jeopardizing the positive impacts of the new systems. Tanks were being checked for water-tightness both on the fabricators' lots and after arriving in the watershed. Any leaking tanks were either disallowed for installation or repaired on site. However, as direct discharge sampling continued in 2011 and 2012, there were unacceptably high E. coli levels in some discharge where there were concrete tanks which originally seemed to be working. This led to more intensive examinations of these concrete tanks using inground dye testing and photography inside tanks.

Research showed that ground water was infiltrating some of the original concrete tanks. This led to over saturation of the system and inadequate bacterial decontamination. The Commission worked with the tank manufacturer and came to an agreement on a protocol for repairing the tanks. Though manufacturing standards have improved, *the Commission believes concrete tanks are not effective enough in preventing contamination of tributaries and ground water. Only heavy-duty plastic tanks are currently allowed in the Project.*

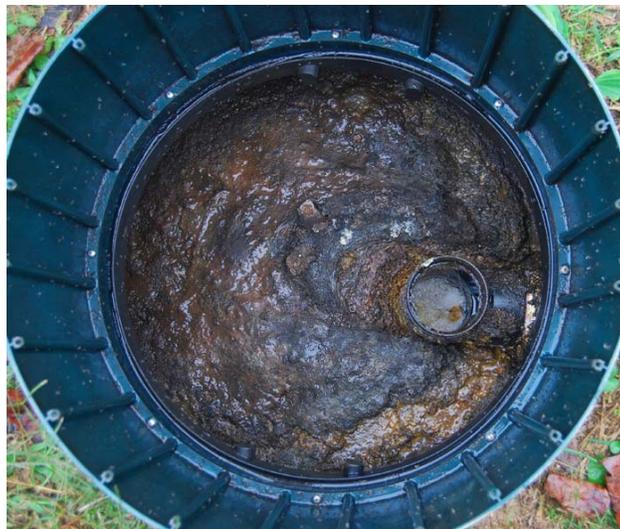
Septic tank with too much grease

One underlying reason for challenges to the Project is the reality of low income, rural life. The new, high tech wastewater systems installed by the Project are sensitive. Often homeowners need to change the way they use water and deal with waste. In the past, peoples' systems were inadequate, but they could deal more easily with kitchen wastes, oil and grease, sanitary products, and surges in water use. New systems often are threatened by surges in water use which come when many loads of wash are done on the same day, or when reunions or family situations increase the number of people staying at the house. One of the challenges of the Project has been to get people to change their life-long habits and lifestyles. In a few instances improper disposal of kitchen grease has threatened long term viability of systems. In these cases, the Project has worked closely with homeowners to insure grease is disposed of properly.

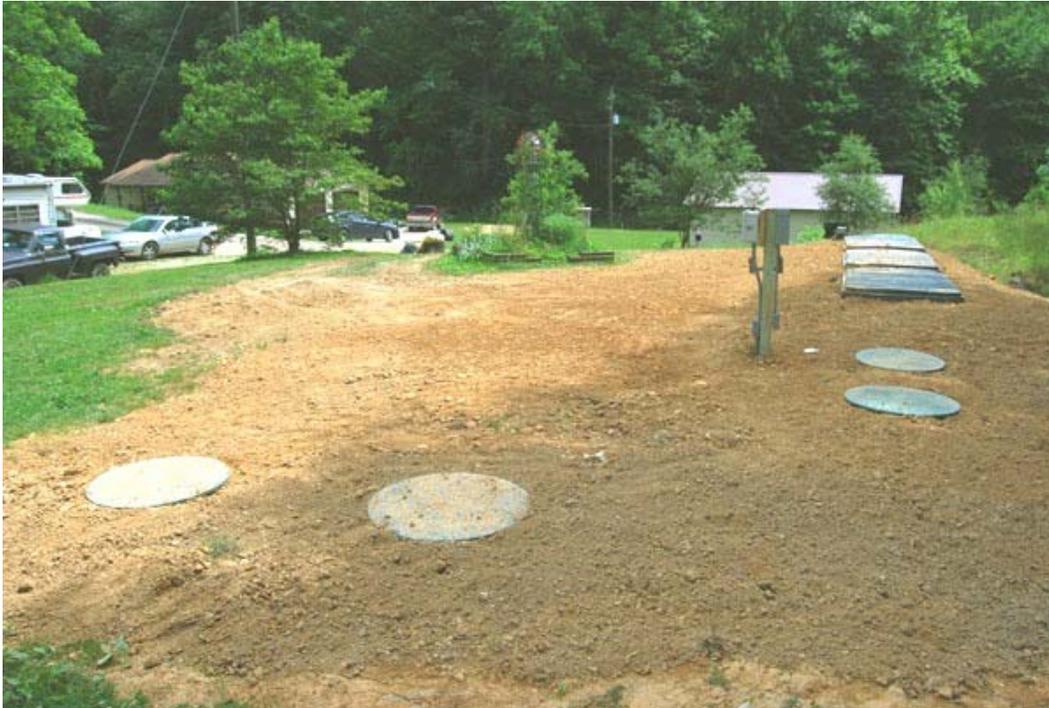
Typical new system installation in Phase 3

Phase 3 continued the work in the Left Fork Watershed as well as continuing the collaboration with the WV DEP. Phase 3 funded another **25 home installations** during 2011 and 2012. All systems had Anua (Bord na Mona) peat technology as secondary treatment, followed by Salcor UV final disinfection before discharging into tributaries.
