Green SRF Wastewater Projects ~ Phase 4

**Lincoln County Commission ~ US EPA ~
WV DEP ~ WV DHHR Cooperative Projects**

Final Adaptor Ring Report

~ January 2013 ~

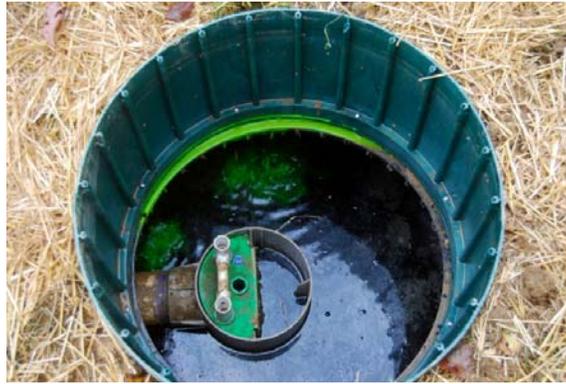
opening and the first riser. It was at the ring where the Project had multiple leaking / infiltration problems.

Dyed water coming from outside the adaptor ring demonstrates leaking and infiltration

In the end what worked was using Infiltrator risers, putting the Polylok adaptor ring on **the very top riser** and attaching the Polylok lid to the ring. The initial Infiltrator riser was attached to the tank using mastic and screwed down using the proscribed star pattern. Between all other risers, CS-1500 was used as a sealant.
